TITLE: Thermal cycling test of RCA sky load cylinder

DOC. TYPE: TEST REPORT

REF. NUMBER : Internal Report 604/2012 **PAGE:** 1 of IV, 10

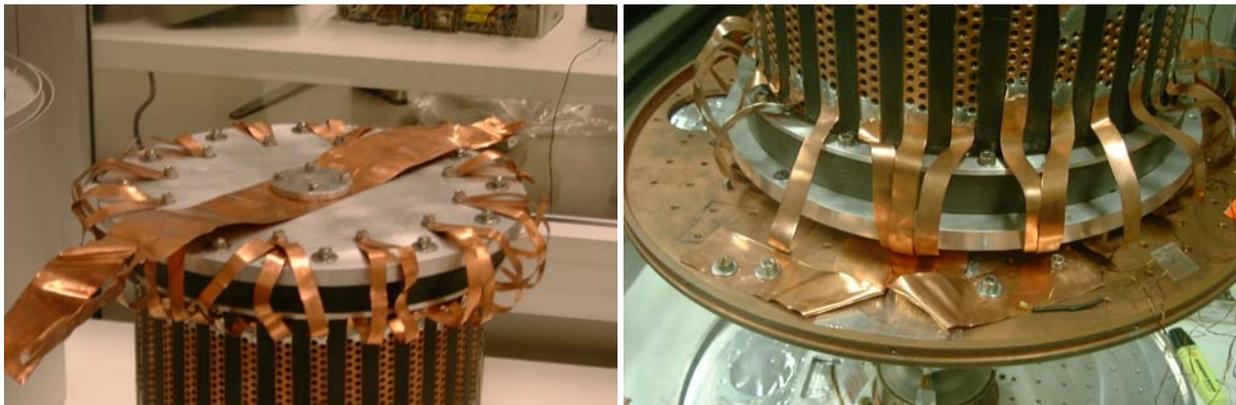
The thermal strap to the cold flange is provided by a copper slab (0.25 mm thick), fixed to the Aluminum base (Fig. 2).

Fig. 2 A wide copper slab is attached to the Aluminum base (left figure) and then fixed to the facility cold flange (right figure).

Temperature data show the need of a good thermal strap conductance in order to optimize the cooldown time.

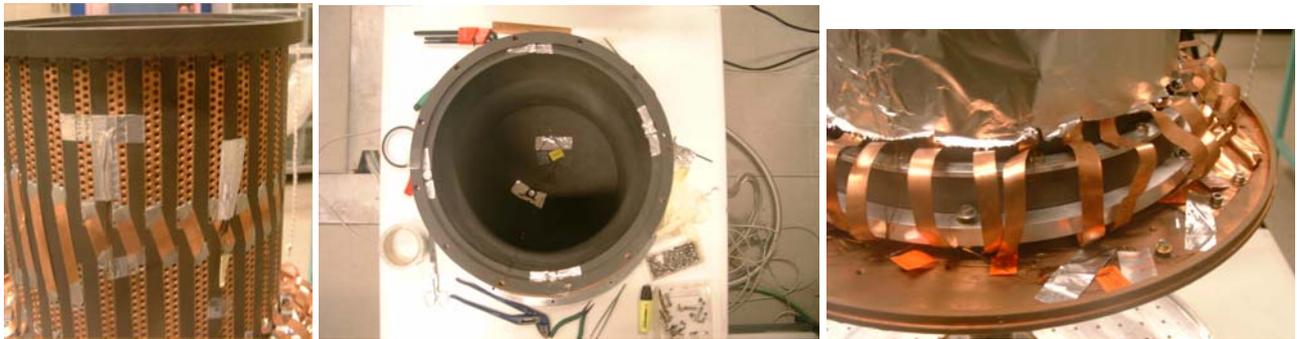
Sensor ID	Type	Fixation	Location
A	DT670 (cal)	Al tape	Lateral wall of the cylinder (T-shaped tape in Fig. 3, left)
B	CX1050 (cal)	Al tape	Eccosorb cylinder internal base (Fig. 3, central)
C1	DT670	Screw	Al base (Fig. 3, right)
C2	-	-	Not in use
C3	DT670	Al tape	Lateral wall of the cylinder (straight tape in Fig. 3, left)
C4	DT670	Screw	Cold flange (Fig. 3, right)
D1	DT670	Al tape	Top of the cylinder (Fig. 3, central)
D2	DT670	Al tape	Top of the cylinder (Fig. 3, central)
D3	DT670	Al tape	Top of the cylinder (Fig. 3, central)
D4	DT670	Al tape	Top of the cylinder (Fig. 3, central)

Fig. 3 Sensors locations. Sensors A and C3 are displayed in the left panel, sensors B, D1, D2, D3, D4 in central panel and sensors C1, C4 in the right panel.

Sensors C3 and B show temperatures outside the typical accuracies.

This could be explained with the worsening of the fixation for the C3, while the use of the calibrated sensor for the B channel would not let us to univocally explain that difference.

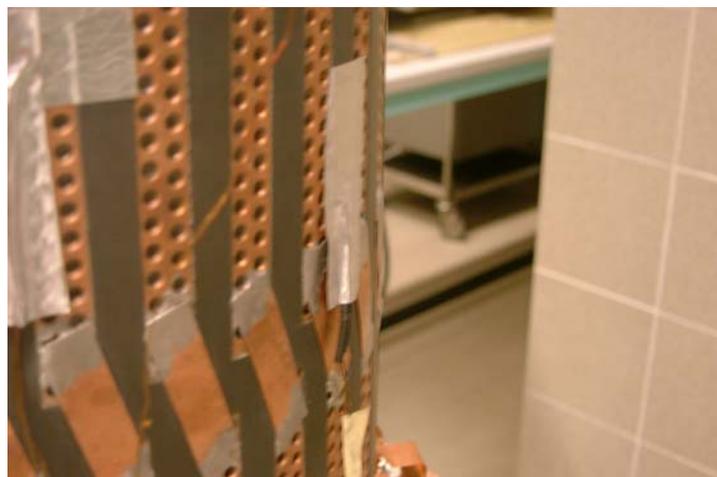
The Aluminum tape on the sensors mounted on the lateral wall of cylinder was found detached in the low part (Fig. 12).

Fig. 12 Aluminum tape on the lateral wall sensors was found slightly detached.

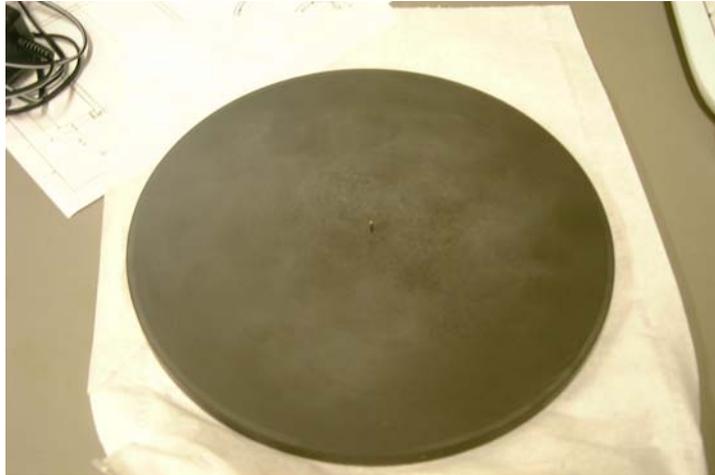
The load was demounted from the cryochamber. No change was found, no cracks or flake were observed (Fig. 13).

Fig. 13 No change was observed in the load base.
